**Flood Control Project Maintenance  
Levee Inspections**  
**LMA District Cover Sheet**  
**Spring 2019 Levee Inspection Results**

**Sacramento River West Side Levee District**

**Spring 2019 Levee Inspection Results**

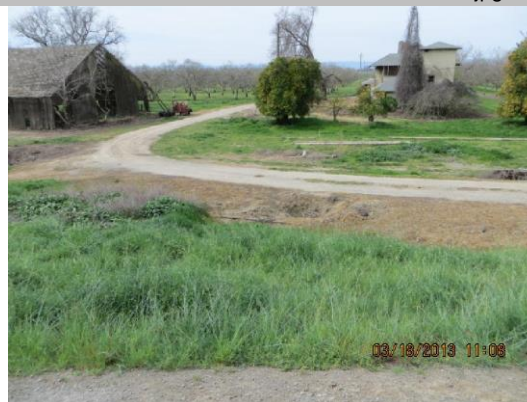
Photo 2 of 3 : UCIP\_SP\_2019\_10426\_17704.jpg

Comment Code						
Inspector Comment						
FS_ID:10426 DS_ID:20345 EP_NO: 9374 Repair Type: Non-Urgent Crossing Status: Found UCIP Comments: Verify if pipe is abandoned with landowner and remove or abandon properly if necessary. FIELD_STRUCT_DESC: *ABANDONED* 3 of 3: 24-inch concrete encased steel drainage pipe through the levee, 17 feet below the crown. Slide gate on concrete headwall on waterside (WS) end. Walkway to control gate and gate valve on landside (LS) end. (24-inch pipe [HLM 36.61] authorized under Automatic Board Order (ABO) issued as Permit No. 9374, 1974 - Richard H. Moore). [Additional Reference(s): USACE Sacramento O&M Manual 131, May 1960 (HLM 36.61)]. FS Date: 3/18/2013

Headwall and gate valve on LS toe buried but partially exposed.

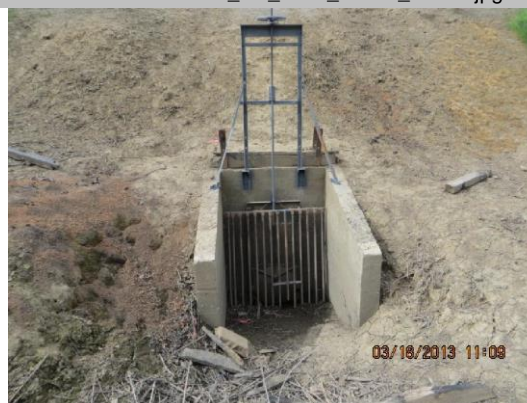
Photo 3 of 3 : UCIP\_SP\_2019\_10426\_17703.jpg

Item	DWR UCIP LMA Responsibility			39.111233 °	39.111233 °	
				-121.911450 °	-121.911450 °	
DWR ID	20345					
Comment Code						
Inspector Comment						
FS_ID:10426 DS_ID:20345 EP_NO: 9374 Repair Type: Non-Urgent Crossing Status: Found UCIP Comments: Verify if pipe is abandoned with landowner and remove or abandon properly if necessary. FIELD_STRUCT_DESC: *ABANDONED* 3 of 3: 24-inch concrete encased steel drainage pipe through the levee, 17 feet below the crown. Slide gate on concrete headwall on waterside (WS) end. Walkway to control gate and gate valve on landside (LS) end. (24-inch pipe [HLM 36.61] authorized under Automatic Board Order (ABO) issued as Permit No. 9374, 1974 - Richard H. Moore). [Additional Reference(s): USACE Sacramento O&M Manual 131, May 1960 (HLM 36.61)]. FS Date: 3/18/2013

Outlet/inlet on WS toe.

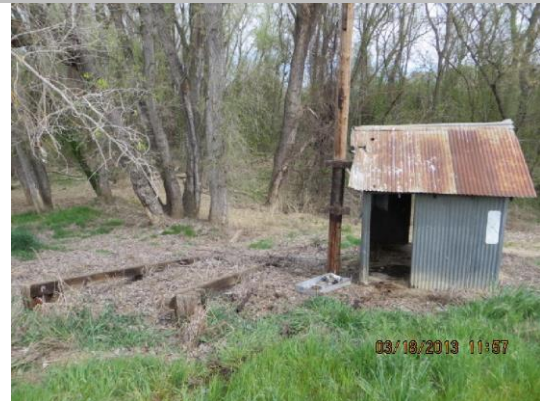
Photo 3 of 3 : UCIP\_SP\_2019\_10444\_17723.jpg

Item	DWR UCIP Field Study			39.112377 °	39.112377 °	
				-121.912286 °	-121.912286 °	
DWR ID	20274					
Comment Code						
Inspector Comment						
FS_ID:10444						
DS_ID:20274						
EP_NO: 9374						
Repair Type: Non-Urgent						
Crossing Status: Found						
UCIP Comments: Pipe should be abandoned properly.						
FIELD_STRUCT_DESC: 4 of 4: 24-inch corrugated metal irrigation pipe through the levee, 15.5 feet below the crown. Two corrugated metal cutoff walls. Slide gate in a 36-inch corrugated metal riser unit on the waterside (WS) slope. Pump house with no connection on the WS bank. 12-inch steel pipe with steel plate over end at WS toe (likely pump connection point). 6-foot diameter concrete riser on landside (LS) toe. Skid rails mounted on wood piling on the WS slope. Department of Water Resources B.M. SR 47 on top of concrete anchor post on the WS shoulder. Power pole and meter box on the WS shoulder. Switch panel in metal house on the WS slope. Concrete standpipe on the LS. Overhead power line crosses the levee to service pole. (Automatic Board Order (ABO) issued as Permit No. 9374, 1974 - Richard H. Moore). [Additional Reference(s): DWR Levee Log, 2006].

Pump house, JP, and wooden ramp on WS slope.

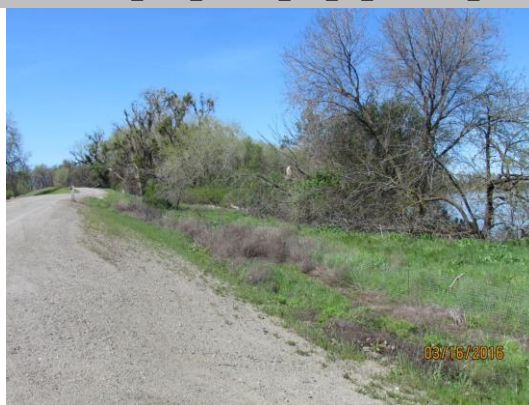
Photo 1 of 2 : SP\_2019\_NA0016\_435\_33\_20190304\_00013.jpg

LM Start	37.07	Rating **	A/W	Issue No.	33
LM End	37.15	Issue Type +	Ob	Location *	WS
Category	Earthen Levee			GPS Latitude/Longitude	
				Start	End
Item	Vegetation			39.121003 °	39.121547 °
				-121.919888 °	-121.921278 °
DWR ID	DWR_NA0016_01_s_2012_33				
Comment Code					
V8 : Environmental Requirements.					
Inspector Comment					
Revegetation site is fenced off.

View of the revegetation site on the waterward berm of the levee looking upstream. Spring 2016.

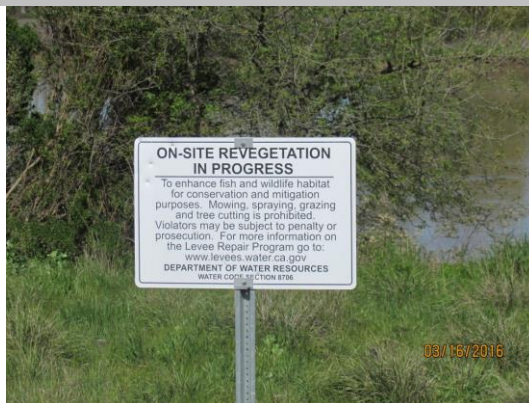
Photo 2 of 2 : SP\_2019\_NA0016\_435\_33\_20190304\_00014.jpg

Sign stating the revegetation site. Spring 2016.

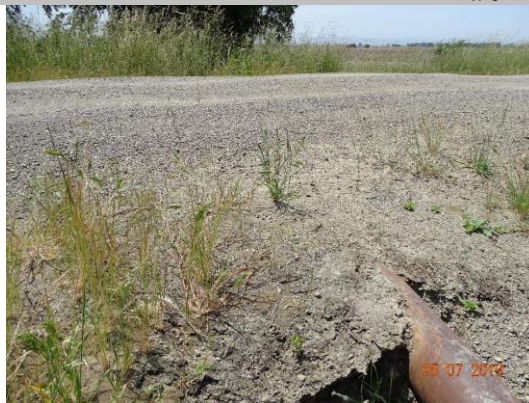
Photo 1 of 3 : UCIP\_SP\_2019\_54061\_79354.jpg

Comment Code					
Inspector Comment					
FS_ID:54061 DS_ID:20307 EP_NO: 1734 Repair Type: Urgent Crossing Status: Found UCIP Comments: 05/22/2019 Failed siphon breaker lets water out of pipe on WS slope that creates erosion around the pipe. Noticed multiple through holes in pipe outlet on river's edge. (DWR UCIP - OYakimov) Good candidate for video inspection as pipe is heavily rusted at outlet. FIELD_STRUCT_DESC: 8-inch steel drainage pipe through the levee, 1 foot below the crown. One metal cutoff wall. Vertical pumping unit in drainage ditch at the landside (LS) toe. Siphon breaker on the waterside (WS) slope. (Permit No. 1734, 1953 - Davis Ranches). [Additional Reference(s): DWR Levee Log, 1980. USACE Sacramento O&M Manual 131, May 1960 (HLM 37.95)]. FS Date: 5/22/2019 8:03:31 AM

View of levee crown at crossing

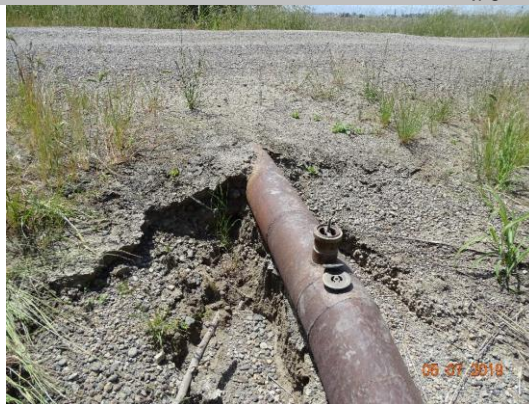
Photo 2 of 3 : UCIP\_SP\_2019\_54061\_79355.jpg

Erosion on WS slope

Item	DWR UCIP Field Study			39.124064 °	39.124064 °	
				-121.926198 °	-121.926198 °	
DWR ID	20307					
Comment Code						
Inspector Comment						
FS_ID:54061 DS_ID:20307 EP_NO: 1734 Repair Type: Urgent Crossing Status: Found UCIP Comments: 05/22/2019 Failed siphon breaker lets water out of pipe on WS slope that creates erosion around the pipe. Noticed multiple through holes in pipe outlet on river's edge. (DWR UCIP - OYakimov) Good candidate for video inspection as pipe is heavily rusted at outlet. FIELD_STRUCT_DESC: 8-inch steel drainage pipe through the levee, 1 foot below the crown. One metal cutoff wall. Vertical pumping unit in drainage ditch at the landside (LS) toe. Siphon breaker on the waterside (WS) slope. (Permit No. 1734, 1953 - Davis Ranches). [Additional Reference(s): DWR Levee Log, 1980. USACE Sacramento O&M Manual 131, May 1960 (HLM 37.95)]. FS Date: 5/22/2019 8:03:31 AM

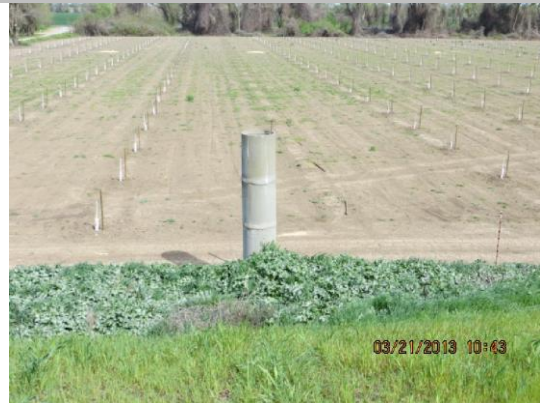
Photo 1 of 3 : UCIP\_SP\_2019\_10528\_17854.jpg

Comment Code						
Inspector Comment						
FS_ID:10528 DS_ID:20282 EP_NO: 9352 Repair Type: Non-Urgent Crossing Status: Found UCIP Comments: Pipe appears to have been removed from levee section. Need to verify pipe abandonment. FIELD_STRUCT_DESC: 12-inch steel irrigation pipe through the levee, 5 feet below the crown. Switch house on the waterside (WS) shoulder. Pump and gate valve on the WS bank. Concrete discharge standpipe on the landside (LS). (For a 14-inch pipe, Permit No. 635, 1935 - Henry F. Schmidt). (Automatic Board Order (ABO) issued as Permit No. 9351, 1974 - W. A. Gerrans). [Additional Reference(s): DWR Levee Log, 2006. USACE Sacramento O&M Manual 131, May 1960 (HLM 40.43)]. FS Date: 3/21/2013

Concrete standpipe at LS toe.

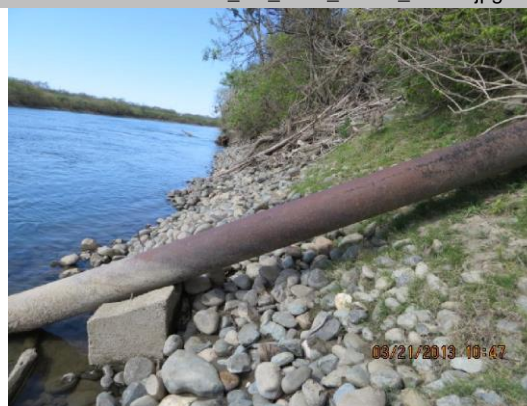
Photo 2 of 3 : UCIP\_SP\_2019\_10528\_17853.jpg

Item	DWR UCIP Field Study			39.143387 °		39.143387 °
				-121.927196 °		-121.927196 °
DWR ID	20282					
Comment Code						
Inspector Comment						
FS_ID:10528 DS_ID:20282 EP_NO: 9352 Repair Type: Non-Urgent Crossing Status: Found UCIP Comments: Pipe appears to have been removed from levee section. Need to verify pipe abandonment. FIELD_STRUCT_DESC: 12-inch steel irrigation pipe through the levee, 5 feet below the crown. Switch house on the waterside (WS) shoulder. Pump and gate valve on the WS bank. Concrete discharge standpipe on the landside (LS). (For a 14-inch pipe, Permit No. 635, 1935 - Henry F. Schmidt). (Automatic Board Order (ABO) issued as Permit No. 9351, 1974 - W. A. Gerrans). [Additional Reference(s): DWR Levee Log, 2006. USACE Sacramento O&M Manual 131, May 1960 (HLM 40.43)]. FS Date: 3/21/2013

Pipe visible at WS toe.

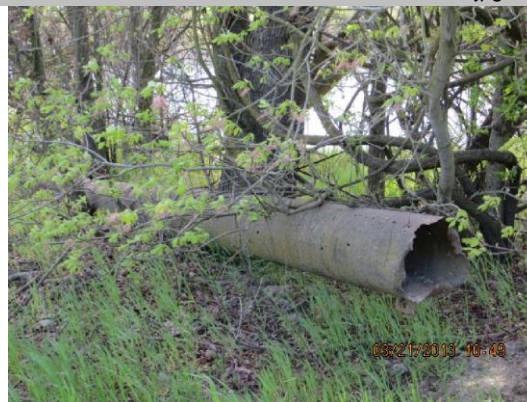
Photo 3 of 3 : UCIP\_SP\_2019\_10528\_17852.jpg

12-inch pipe debris on WS berm.

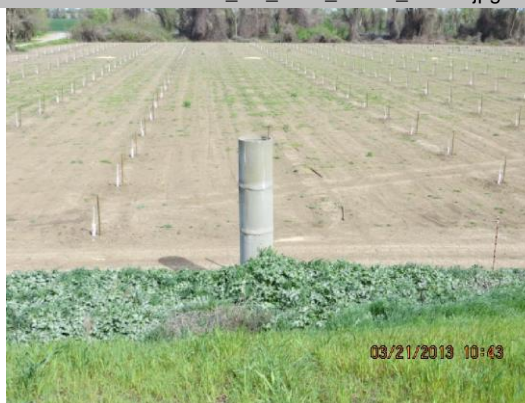
Photo 1 of 2 : UCIP\_SP\_2019\_11343\_18741.jpg

LM Start	39.93	Rating **	M	Issue No.	1601
LM End	39.93	Issue Type +	En	Location *	
Category	Supplemental			GPS Latitude/Longitude	
				Start	End
Item	DWR UCIP Field Study			39.143387 °	39.143387 °
				-121.927196 °	-121.927196 °
DWR ID	22966				
Comment Code					
Inspector Comment					
FS_ID:11343					
DS_ID:22966					
EP_NO: 9352					
Repair Type: Non-Urgent					
Crossing Status: Found					
UCIP Comments: Pipe should be removed.					
FIELD_STRUCT_DESC: 1.5-inch galvanized steel electrical conduit through the levee, at an unknown depth. Visible on the waterside (WS) slope. (Permit No. 635, 1935 - Henry F. Schmidt).					
FS Date: 3/21/2013

Electrical conduit approximately perpendicular to concrete riser on LS toe.

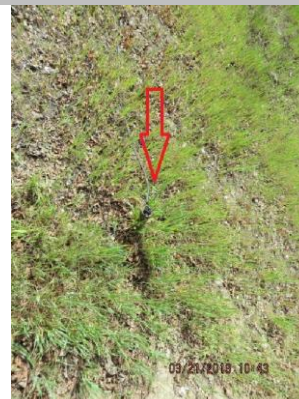
Photo 2 of 2 : UCIP\_SP\_2019\_11343\_18740.jpg

1.5-inch electrical conduit on WS slope.

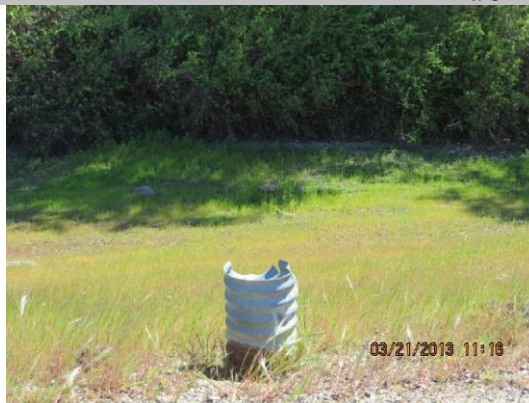
Photo 1 of 3 : UCIP\_SP\_2019\_10527\_17850.jpg

LM Start	40.44	Rating **	M	Issue No.	1602
LM End	40.44	Issue Type +	En	Location *	
Category	Supplemental			GPS Latitude/Longitude	
				Start	End
Item	DWR UCIP Field Study			39.143838 °	39.143838 °
				-121.919338 °	-121.919338 °
DWR ID	20285				
Comment Code					
Inspector Comment					
FS_ID:10527 DS_ID:20285 EP_NO: 12799 Repair Type: Non-Urgent Crossing Status: Found UCIP Comments: Pipe appears abandoned. Need to verify type of abandonment FIELD_STRUCT_DESC: 18-inch steel irrigation pipe through the levee, 6.5 feet below the crown. 30-inch corrugated metal standpipe on landside (LS) toe. Pump on the waterside (WS) toe. Vent inside a 12-inch corrugated metal riser unit on the WS shoulder. (Permit No. 12799, 1979 - Bruce Myers). [Additional Reference(s): DWR Levee Log, 2006]. FS Date: 3/21/2013

Vent in 12-inch CMP riser on WS shoulder.

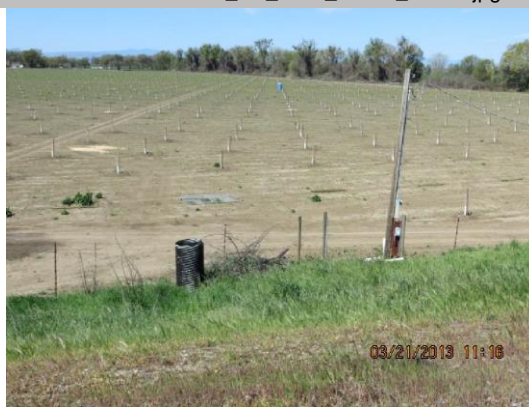
Photo 2 of 3 : UCIP\_SP\_2019\_10527\_17849.jpg

30-inch CMP riser with slide gate at LS toe.

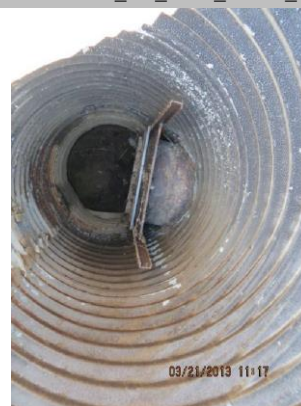
Photo 3 of 3 : UCIP\_SP\_2019\_10527\_17848.jpg

Slide gate in CMP riser on LS toe.

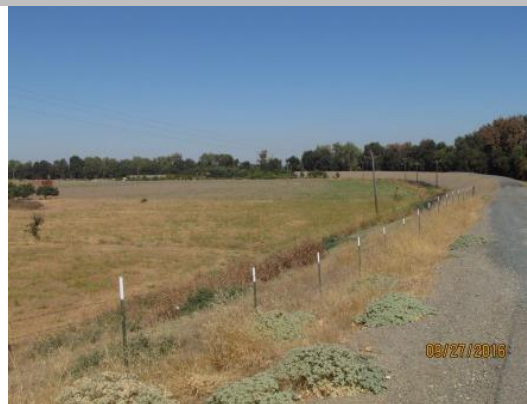
Photo 1 of 1 : SP\_2019\_NA0016\_435\_102\_20190304\_00035.jpg

LM Start	40.64	Rating **	M	Issue No.	102
LM End	40.72	Issue Type +	En	Location *	LS
Category	Earthen Levee			GPS Latitude/Longitude	
				Start	End
Item	Encroachments			39.146602 °	39.147582 °
				-121.918897 °	-121.918429 °
DWR ID	DWR_NA0016_01_s_2015_102				
Comment Code					
FE : Fence					
Inspector Comment

View of owner's fence on landside. Fall 2016 inspection.

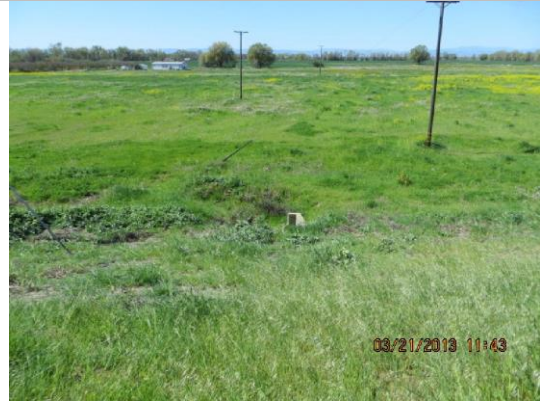
Photo 1 of 3 : UCIP\_SP\_2019\_10533\_17865.jpg

Comment Code					
Inspector Comment					
FS_ID:10533 DS_ID:20287 EP_NO: 9351 Repair Type: Non-Urgent Crossing Status: Found UCIP Comments: Appears abandoned. Should be abandoned properly. FIELD_STRUCT_DESC: 30-inch corrugated metal irrigation pipe through the levee, 17.5 feet below the crown. Slide gate on the waterside (WS) end. Discharges into a concrete box at the landside (LS) toe. Small pump discharges into a sump area in front of slide gate at WS toe. (Automatic Board Order (ABO) issued as Permit No. 9351, 1974 - W. A. Gerrans). [Additional Reference(s): DWR Levee Log, 2006. USACE Sacramento O&M Manual 131, May 1960 (HLM 41.39)]. FS Date: 3/21/2013

Demolished concrete distribution box at LS toe.

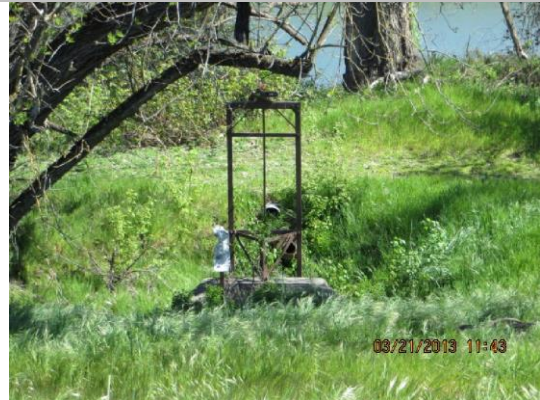
Photo 2 of 3 : UCIP\_SP\_2019\_10533\_17864.jpg

Slide gate at WS toe.

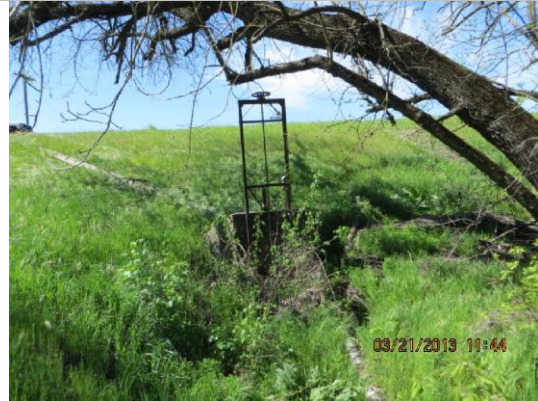
Photo 3 of 3 : UCIP\_SP\_2019\_10533\_17863.jpg

Slide gate at WS toe.

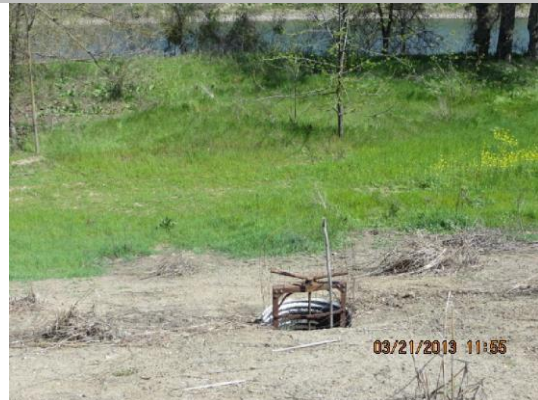
Photo 1 of 3 : UCIP\_SP\_2019\_10535\_17877.jpg

Comment Code						
Inspector Comment						
FS_ID:10535 DS_ID:20288 EP_NO: N/A Repair Type: No Action Needed Crossing Status: Found UCIP Comments: FIELD_STRUCT_DESC: 24-inch drainage pipe of an unknown material through the levee, 19 feet below the crown. 6-foot diameter corrugated metal standpipe on the landside (LS) toe. Pump and 24-inch pipe on the LS. Slide gate in corrugated metal riser unit on waterside (WS) slope. Concrete block wall at WS toe for discharge line. (Modified under Permit No. 8587, 1973 - Anthony E. Steidlmyer). [Additional Reference(s): DWR Levee Log, 2006. USACE Sacramento O&M Manual 131, May 1960 (HLM 41.56)]. FS Date: 3/21/2013

Slide gate in CMP riser on WS slope.

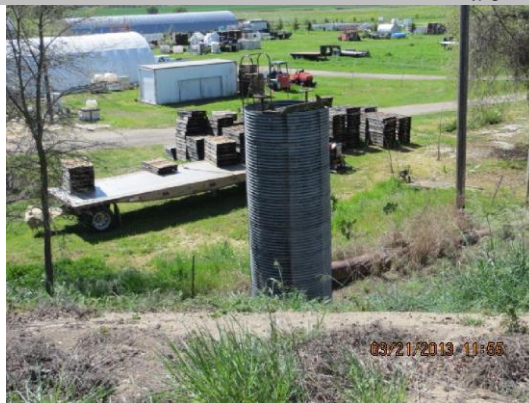
Photo 2 of 3 : UCIP\_SP\_2019\_10535\_17876.jpg

6-foot diameter CMP riser with slide gates on LS toe.

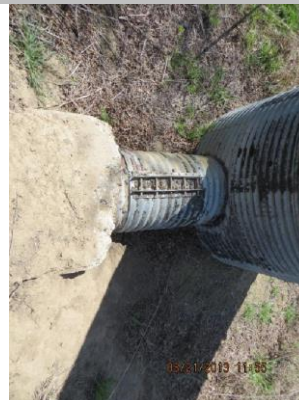
Photo 3 of 3 : UCIP\_SP\_2019\_10535\_17875.jpg

24-inch CMP at connection to CMP riser on LS toe.

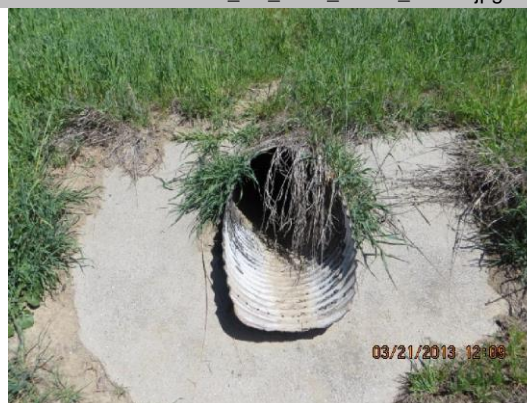
Photo 1 of 3 : UCIP\_SP\_2019\_10536\_17883.jpg

LM Start	41.86	Rating **	M	Issue No.	1605
LM End	41.86	Issue Type +	En	Location *	
Category	Supplemental			GPS Latitude/Longitude	
				Start	End
Item	DWR UCIP Field Study			39.158648 °	39.158648 °
				-121.932429 °	-121.932429 °
DWR ID	20289				
Comment Code					
Inspector Comment					
FS_ID:10536 DS_ID:20289 EP_NO: 9341 Repair Type: Non-Urgent Crossing Status: Found UCIP Comments: Appears abandoned. Needs to be abandoned properly. FIELD_STRUCT_DESC: 30-inch irrigation pipe of an unknown material through the levee, 19.5 feet below the crown. Slide gate in a 36-inch corrugated metal riser unit on the waterside (WS) slope. (Automatic Board Order (ABO) issued as Permit No. 9341, 1974 - F. J. Steidlmayer). [Additional Reference(s): DWR Levee Log, 2006. USACE Sacramento O&M Manual 131, May 1960 (HLM 42.37)]. FS Date: 3/21/2013

30-inch CMP at outlet on LS toe.

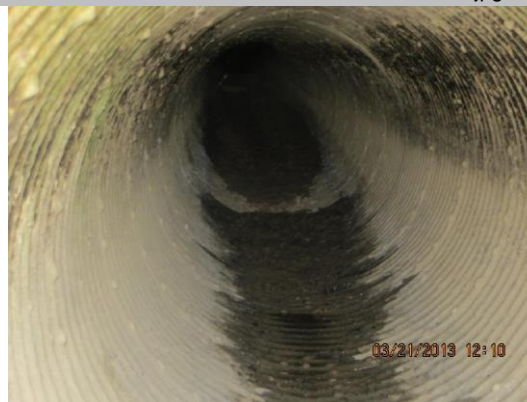
Photo 2 of 3 : UCIP\_SP\_2019\_10536\_17882.jpg

View from LS toe of CMP pipe.

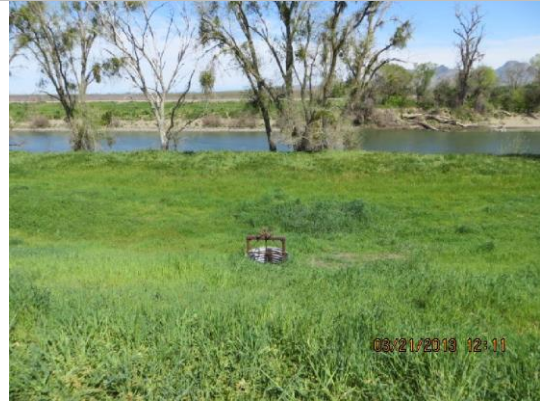
Photo 3 of 3 : UCIP\_SP\_2019\_10536\_17881.jpg

Slide gate in CMP riser on WS toe.

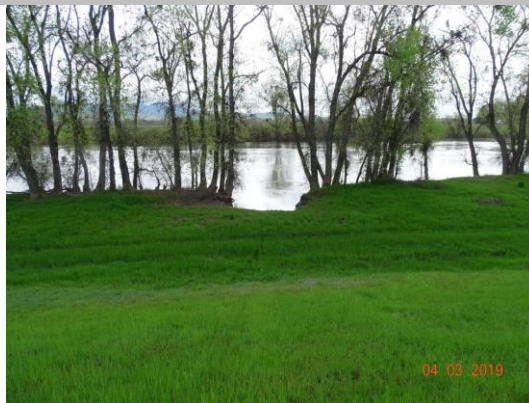
Photo 1 of 1 : SP\_2019\_NA0016\_435\_119\_20190404\_00219.jpg

LM Start	42.47	Rating **	A/W	Issue No.	119
LM End	42.47	Issue Type +	Ma	Location *	WS
Category	Earthen Levee			GPS Latitude/Longitude	
				Start	End
Item	Erosion / Bank Caving			39.166313 °	39.166313 °
				-121.937546 °	-121.937546 °
DWR ID	DWR_NA0016_01_s_2019_119				
Comment Code					
E1 : Note and monitor erosion site.					
Inspector Comment					
There appears to be a new erosion on the waterside berm. Recommend monitoring.

View of erosion from the crown. Spring 2019.

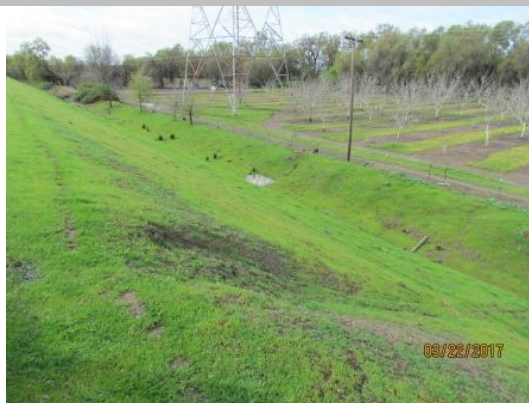
Photo 1 of 2 : SP\_2019\_NA0016\_435\_146\_20190304\_00056.jpg

LM Start	42.73	Rating **	A/W	Issue No.	146
LM End	42.73	Issue Type +	Ma	Location *	LS
Category	Earthen Levee			GPS Latitude/Longitude	
				Start	End
Item	Slope Stability			39.169949 °	39.169949 °
				-121.938664 °	-121.938664 °
DWR ID	DWR_NA0016_01_f_2015_146				
Comment Code					
S2 : Repair the levee slope damaged by foot traffic and prevent access where possible.					
Inspector Comment

Slope stability issue due to foot traffic. Spring 2017.

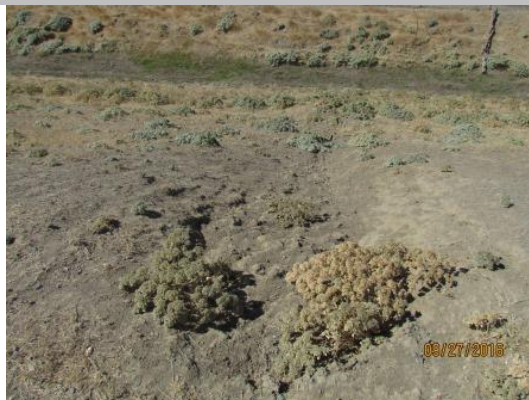
Photo 2 of 2 : SP\_2019\_NA0016\_435\_146\_20190304\_00057.jpg

Slope stability issue due to foot traffic. Fall 2016 inspection.

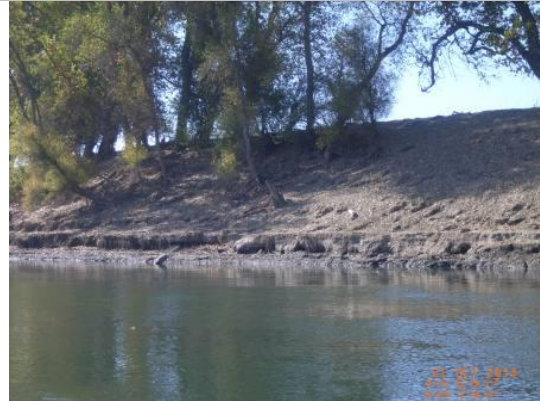
Photo 1 of 1 : SP\_2019\_NA0016\_435\_95\_20190304\_00030.jpg

LM Start	42.90	Rating **	A/W	Issue No.	95
LM End	43.09	Issue Type +	Ma	Location *	WS
Category	Supplemental			GPS Latitude/Longitude	
				Start	End
Item	2017 USACE Erosion Survey, DRAFT			39.172501 °	39.174949 °
				-121.939053 °	-121.940737 °
DWR ID	DWR_NA0016_01_f_2018_95				
Comment Code					
Inspector Comment					
2017 Site ID: SAC 136.6 R					
Status: Eroding					
2017 Field Notes: New erosion observed along the entire bank slope.					
Site History: 2010 - Lower portion of 136.7 that did not extend far enough. Abrupt transition from upstream site. 2012 - Site extended upstream, minor new erosion. 2013 - Minor new erosion at the toe.					
New tree popout. Downstream limit extended. 2016 - Site continues to worsen, fresh erosion at toe.

USACE 2013 Photo #1

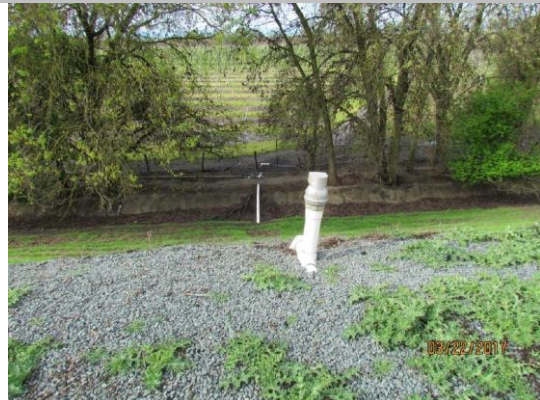
Photo 1 of 3 : UCIP\_SP\_2019\_52625\_76995.jpg

Comment Code					
Inspector Comment					
FS_ID:52625 DS_ID:25485 EP_NO: N/A Repair Type: Non-Urgent Crossing Status: Found UCIP Comments: 05/23/2018 Contacted NA0016 superintendent about history and current status of the crossing. Confirmed that LMA has no additional information about this crossing that was put in before spring of 2017 (DWR UCIP-O.Yakimov) FIELD_STRUCT_DESC: 4-inch polyvinyl chloride (PVC) irrigation pipe through the levee, of an unknown depth below crown. Siphon breaker off landside (LS) shoulder. The pipe irrigates landscape on the waterside of the levee and is not permitted. Pipe found by DWR inspector Zach Jojola during Spring 2017 inspection. FS Date: 4/20/2017

LS view of siphon breaker off LS shoulder. Photo courtesy of Zach Jojola, DWR inspector.

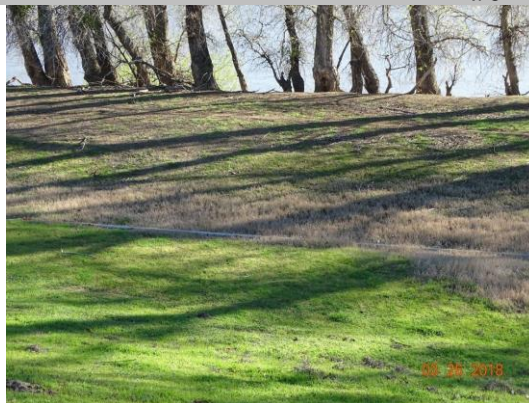
Photo 2 of 3 : UCIP\_SP\_2019\_52625\_77553.jpg

Sprinkler system on the waterside berm. Spring 2018 inspection, photo courtesy of Zach Jojola.

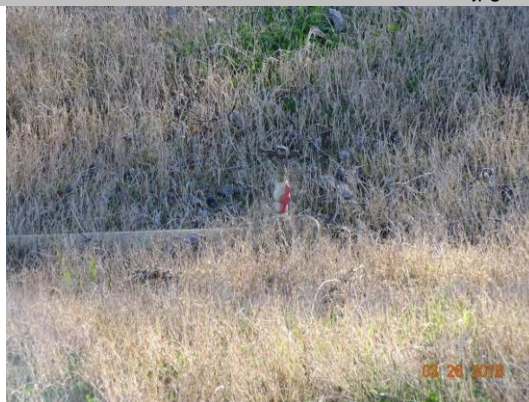
Photo 3 of 3 : UCIP\_SP\_2019\_52625\_77554.jpg

Sprinkler system on the waterside berm. Spring 2018 inspection, photo courtesy of Zach Jojola.

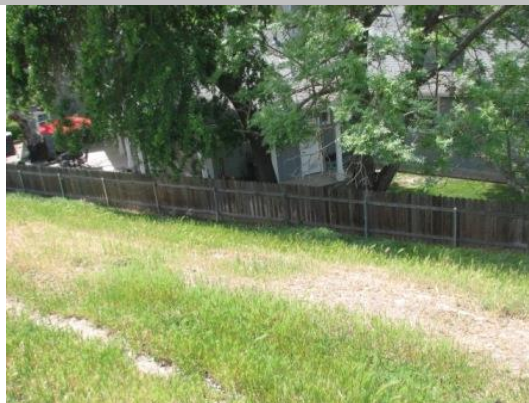
Photo 1 of 1 : SP\_2019\_NA0016\_435\_46\_20190304\_00016.jpg

LM Start	43.24	Rating **	U	Issue No.	46
LM End	43.24	Issue Type +	En	Location *	LS
Category	Earthen Levee			GPS Latitude/Longitude	
				Start	End
Item	Encroachments			39.176429 °	39.176429 °
				-121.942889 °	-121.942889 °
DWR ID	DWR_NA0016_01_s_2012_46				
Comment Code					
FE : Fence					
Inspector Comment

A solid fence along the toe of the levee. Photo taken spring 2012.

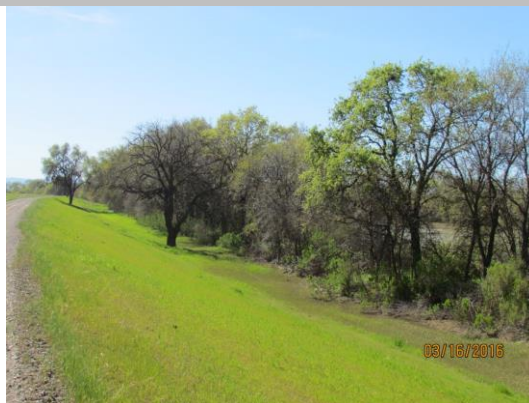
Photo 1 of 2 : SP\_2019\_NA0016\_435\_108\_20190304\_00038.jpg

LM Start	45.39	Rating **	A/W	Issue No.	108
LM End	45.90	Issue Type +	Ob	Location *	WS
Category	Earthen Levee			GPS Latitude/Longitude	
				Start	End
Item	Vegetation			39.192653 °	39.188518 °
				-121.952768 °	-121.960446 °
DWR ID	DWR_NA0016_01_s_2015_108				
Comment Code					
V8 : Environmental Requirements.					
Inspector Comment

View of the revegetation site on the waterward side of the levee looking upstream. Spring 2016.

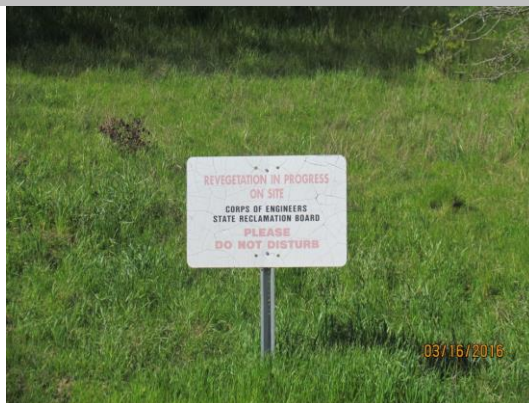
Photo 2 of 2 : SP\_2019\_NA0016\_435\_108\_20190304\_00039.jpg

Sign stating revegetation site. Spring 2016.

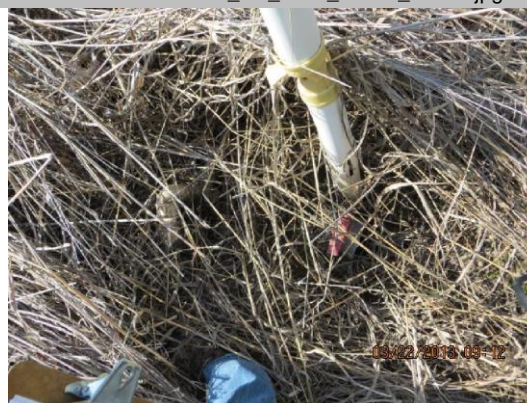
Photo 2 of 3 : UCIP\_SP\_2019\_46812\_17908.jpg

Item	DWR UCIP Field Study			39.187497 °	39.187497 °	
				-121.962074 °	-121.962074 °	
DWR ID	20314					
Comment Code						
Inspector Comment						
FS_ID:46812 DS_ID:20314 EP_NO: 15763 Repair Type: Non-Urgent Crossing Status: Found UCIP Comments: Fresno valve on WS shoulder is broken. Pipe appears to be abandoned. Need to abandon properly if necessary. site visit on 10/09/2015 indicates water is present somewhere along the waterside levee slope. Possibly siphon breaker or fresno valve sprays and drains down levee slope from WS shoulder. internal inspection of pipe recommended to determine source of leak. Pipe is active, but can be removed and capped when not in use. FIELD_STRUCT_DESC: 4-inch galvanized steel irrigation pipe through the levee, 2 feet below the crown. Irrigation valve approximately 50 feet landward of the landside (LS) toe. Fresno valve on the waterside (WS) shoulder with connection for pump at the WS berm. (Permit No. 15763, 1991 - Randy Salverson). FS Date: 3/22/2013

Pipe connection at WS toe.

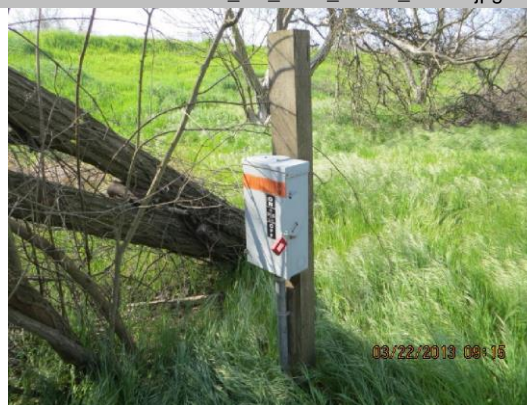
Photo 3 of 3 : UCIP\_SP\_2019\_46812\_17907.jpg

Electrical box at WS berm for portable pump.

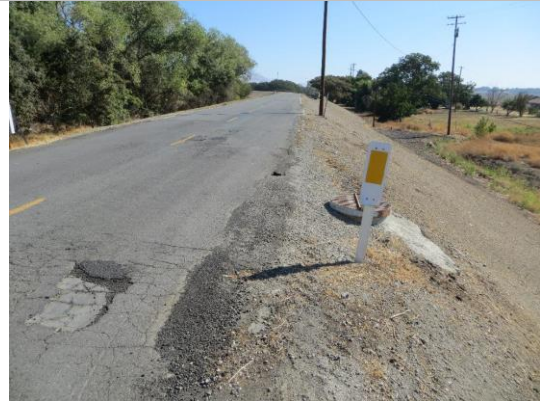
Photo 2 of 3 : UCIP\_SP\_2019\_53020\_74723.jpg

Item	DWR UCIP Field Study			39.186111 °	39.186111 °	
				-121.968069 °	-121.968069 °	
DWR ID	20296					
Comment Code						
Inspector Comment						
FS_ID:53020 DS_ID:20296 EP_NO: 5551 Repair Type: Urgent Crossing Status: Found UCIP Comments: 10/15/2018 Multiple cracks and points of depression on levee crown pavement (Moon Bend Rd). Sink hole on LS shoulder next to CMP riser. Voids around lower part of CMP riser concrete pad on LS shoulder. Condition of this crossing has worsen since last inspection. Recommend internal pipe inspection to determine pipe integrity through levee. (O.Yakimov - DWR)09/23/2016 - A second pipe is visible adjacent to the intake pipe. According to the permit drawings, this pipe is an access pipe for a submersible pump used to clean the fish screen by backwashing. hole on LS shoulder of the levee and Moon Bend Rd. has been patched. No additional road damage is visible. (T. Hatch/UCIP) 09/01/2016 no visible changes from previous inspection. - (T. Hatch/UCIP) 10/09/2015 Possible sink hole along alignment 10-feet LS of siphon breaker on LS slope. Recent road repair along the approximate pipe alignment suggests that levee slumping is related to pipe. It is recommended that further investigation e.g. video inspection or other internal method may help determine if the issue is due to pipe or due to levee settlement in vicinity of the pipe. (T. Hatch/UCIP) FIELD_STRUCT_DESC: 18-inch steel irrigation pipe through the levee, 3 feet below the crown. Pump mounted on a piling structure on the waterside (WS) bank. Switch box on the WS shoulder. Siphon breaker inside a 30-inch corrugated metal riser unit on the landside (LS) shoulder. Pipe discharges into a concrete box at the LS toe. (Automatic Board Order (ABO) issued as Permit No. 9349, 1974 - Ramona Davis). (Pump and pump platform replaced under Permit No. 5551, 1966 - Ramona Davis). (Fish screen installed under Permit No. 17222, 2000 - A&L Rental and Leasing). [Additional Reference(s): DWR Levee Log, 2006]. FS Date: 10/15/2018 7:48:14 AM

Siphon Breaker in 20-inch CMP riser on LS Shoulder. Photo taken from LS looking DS along Moon Bend Rd

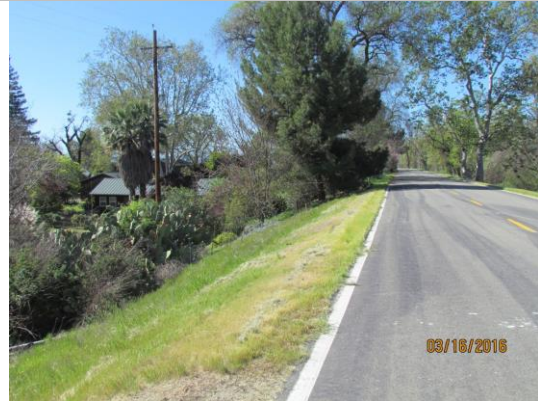
Photo 1 of 1 : SP\_2019\_NA0016\_435\_54\_20190304\_00017.jpg

LM Start	47.01	Rating **	M	Issue No.	54
LM End	47.14	Issue Type +	En	Location *	LS
Category	Earthen Levee			GPS Latitude/Longitude	
				Start	End
Item	Vegetation			39.188544 °	39.189733 °
				-121.979272 °	-121.981232 °
DWR ID	DWR_NA0016_01_s_2012_54				
Comment Code					
V6 : Landscaping					
Inspector Comment					
Cactus on slope and toe of levee, landscape continues along roadway with fence and stairs.

View of the landscaping on the landside slope. Spring 2016.

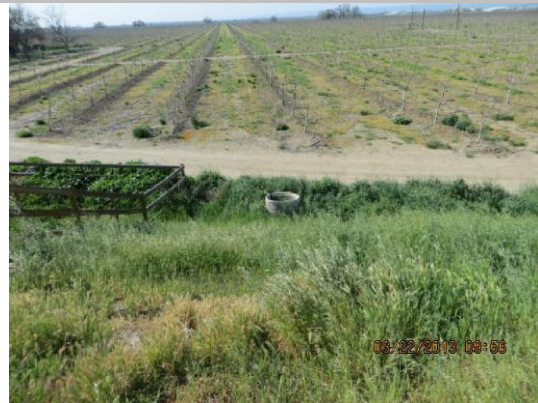
Photo 1 of 1 : UCIP\_SP\_2019\_10553\_17929.jpg

Comment Code					
Inspector Comment					
FS_ID:10553 DS_ID:20298 EP_NO: 9347 Repair Type: Non-Urgent Crossing Status: Indicator Found UCIP Comments: Need to verify type of abandonment. FIELD_STRUCT_DESC: 1 of 2: 24-inch irrigation pipe of an unknown material through the levee, 25.5 feet below the crown. 14-inch pipe sleeved through 24-inch pipe. Annular space grouted. Pump inside pump house on the landside (LS). Gate valve inside pump house on the LS. (Automatic Board Order (ABO) issued as Permit No. 9347, 1974 - Floremon Orchards). [Additional Reference(s): DWR Levee Log, 2006. USACE Sacramento O&M Manual 131, May 1960 (HLM 47.71)]. FS Date: 3/22/2013

Possible location for pipe crossing.

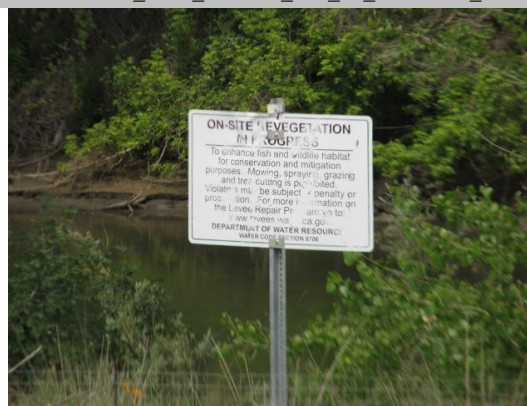
Photo 1 of 1 : SP\_2019\_NA0016\_435\_90\_20190304\_00025.jpg

LM Start	47.19	Rating **	A/W	Issue No.	90
LM End	47.62	Issue Type +	Ob	Location *	WS
Category	Earthen Levee			GPS Latitude/Longitude	
				Start	End
Item	Vegetation			39.189930 °	39.193491 °
				-121.982143 °	-121.988184 °
DWR ID	DWR_NA0016_01_s_2014_90				
Comment Code					
V8 : Environmental Requirements.					
Inspector Comment

A revegetation site along the waterside berm. Spring 2014

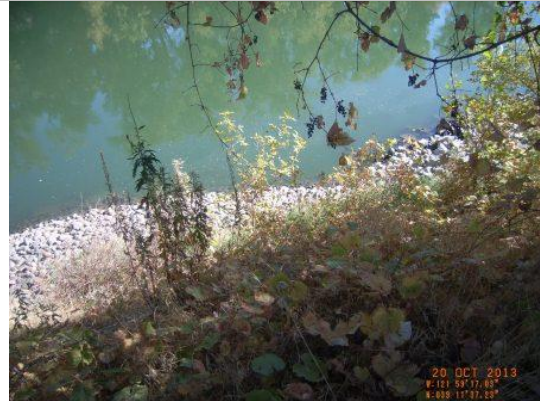
Photo 1 of 1 : SP\_2019\_NA0016\_435\_97\_20190304\_00032.jpg

LM Start	47.62	Rating **	A/W	Issue No.	97
LM End	47.77	Issue Type +	Ma	Location *	WS
Category	Supplemental			GPS Latitude/Longitude	
				Start	End
Item	2017 USACE Erosion Survey, DRAFT			39.193769 °	39.195595 °
				-121.987901 °	-121.988621 °
DWR ID	DWR_NA0016_01_f_2018_97				
Comment Code					
Inspector Comment					
2017 Site ID: SAC 141.5 R					
Status: Eroding					
2017 Field Notes: No observed change.					
Site History: 2010 - Old cobble site starting to unravel at toe. 2011 - Cobbles continue to unravel. 2013 - Site extended downstream to revetment.

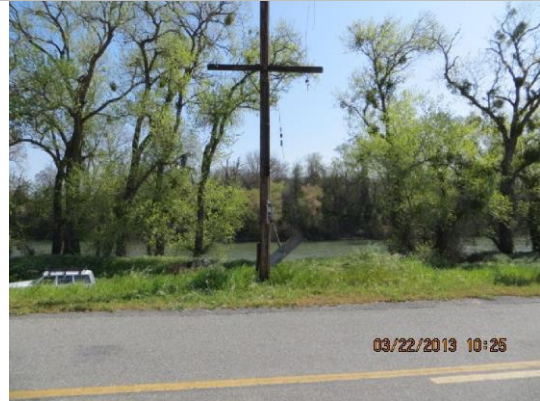
Photo 2 of 2 : UCIP\_SP\_2019\_10563\_17940.jpg

LM Start	47.71	Rating **	M	Issue No.	1610 (cont)	
LM End	47.71	Issue Type +	En	Location *		
Category	Supplemental			GPS Latitude/Longitude		
				Start	End	
Item	DWR UCIP Field Study			39.194772 °	39.194772 °	
				-121.988886 °	-121.988886 °	
DWR ID	20309					
Comment Code						
Inspector Comment						
FS_ID:10563 DS_ID:20309 EP_NO: 9347 Repair Type: Non-Urgent Crossing Status: Indicator Found UCIP Comments: Need to determine type of abandonment. FIELD_STRUCT_DESC: *REMOVED* 2 of 2: 16-inch steel irrigation pipe through the levee, 17.3 feet below the crown. Gate valve on the waterside (WS) end. Pump on the WS bank. Switch box on the WS shoulder. (Automatic Board Order (ABO) issued as Permit No. 9347, 1974 - Floremon Orchards). [Additional Reference(s): DWR Levee Log, 1980. USACE Sacramento O&M Manual 131, May 1960 (HLM 48.23)]. FS Date: 3/22/2013

JP on WS shoulder for removed pump switch house.

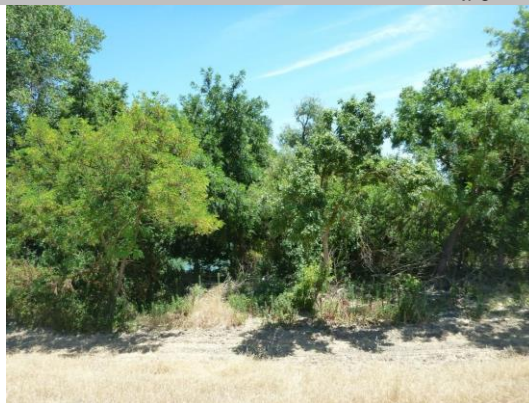
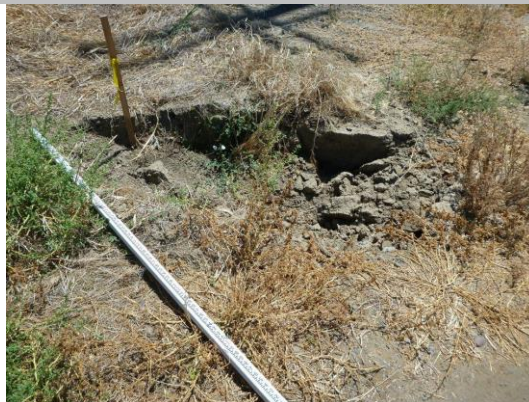
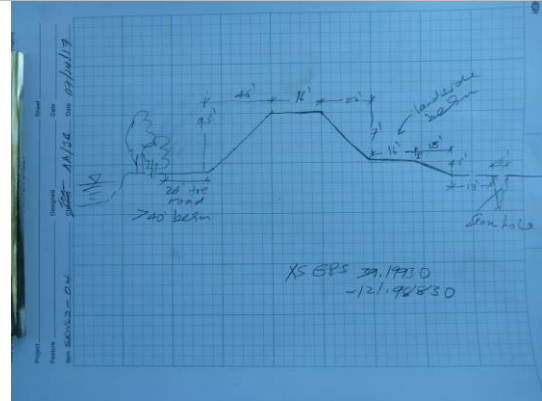
LM Start	47.96	Rating **	A/W	Issue No.	127
LM End	48.03	Issue Type +	Ob	Location *	
Category	Supplemental			GPS Latitude/Longitude	
				Start	End
Item	2017 Storm Damage			39.198380 °	39.199330 °
				-121.988603 °	-121.988197 °
DWR ID	DWR_NA0016_01_f_2017_127				
Comment Code					
Inspector Comment					
Levee Evaluation Comments					
Description:					
Site ID No:186					
Site Designation:SRWLD-04					
Repair Type: Seepage					
Rating:Serious					
Field Date:7/14/2017					
Notes: Berm will be constructed in 2019.

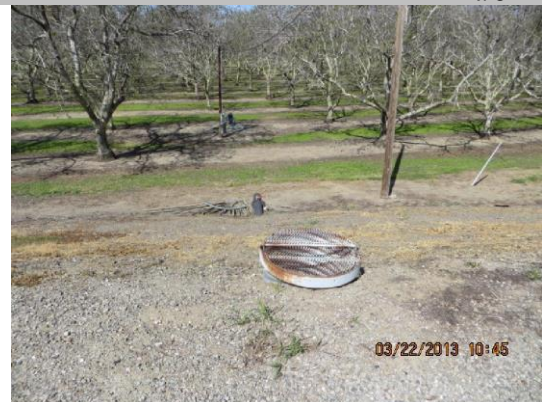
Photo 1 of 3 : UCIP\_SP\_2019\_10566\_17954.jpg

Comment Code					
Inspector Comment					
FS_ID:10566					
DS_ID:20300					
EP_NO: 9343					
Repair Type: Non-Urgent					
Crossing Status: Found					
UCIP Comments: Pipe appears to be abandoned. Need to verify type of abandonment.					
FIELD_STRUCT_DESC: 2 of 2: 24-inch irrigation pipe of an unknown material through the levee, 15.5 feet below the crown. (Pipe measures 12 inches on landside (LS) toe). Slant pump on steel piling structure on the waterside (WS) bank. Butterfly valve at the LS toe. Overhead power line crosses the levee. (Automatic Board Order (ABO) issued as Permit No. 9343, 1974 - Emile F. Cribari). [Additional Reference(s): DWR Levee Log, 2006. USACE Sacramento O&M Manual 131, May 1960 (HLM 48.91)].					
FS Date: 3/22/2013

Siphon Breaker in 30-inch CMP riser on LS shoulder and butterfly valve at LS toe.

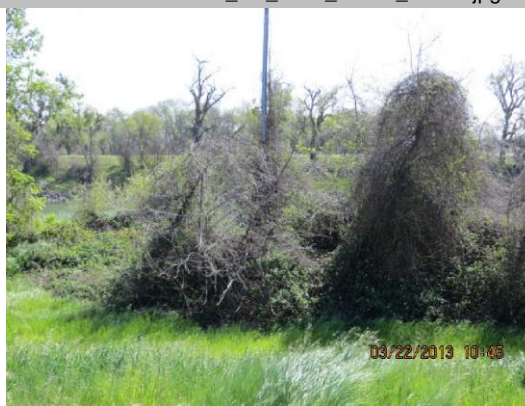
Photo 2 of 3 : UCIP\_SP\_2019\_10566\_17953.jpg

Pump covered in brush on WS berm.

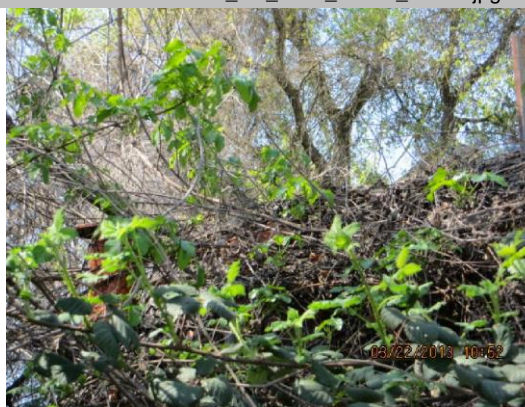
Photo 3 of 3 : UCIP\_SP\_2019\_10566\_17952.jpg

Pump on structure covered in brush on WS berm.

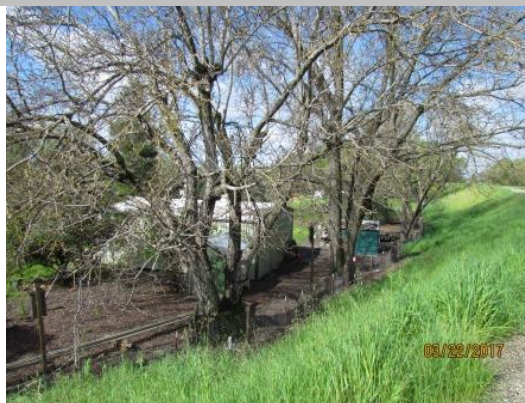
Photo 1 of 1 : SP\_2019\_NA0016\_435\_199\_20190304\_00061.jpg

LM Start	48.58	Rating **	M	Issue No.	199
LM End	49.58	Issue Type +	En	Location *	LS
Category	Earthen Levee			GPS Latitude/Longitude	
				Start	End
Item	Encroachments			39.206495 °	39.213650 °
				-121.984426 °	-121.999883 °
DWR ID	DWR_NA0016_01_s_2017_199				
Comment Code					
FE : Fence					
Inspector Comment					
A fence is along the landside levee toe blocking access.

View of fence along landside levee toe. Spring 2017.

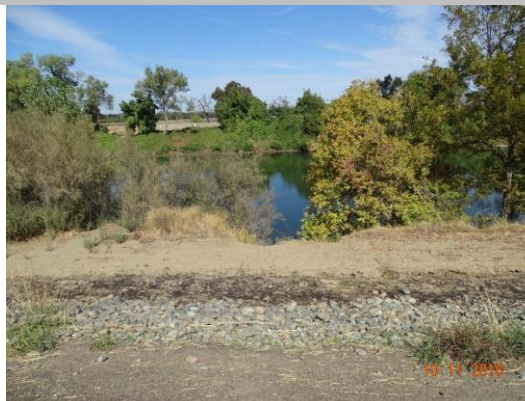
Photo 1 of 1 : SP\_2019\_NA0016\_435\_113\_20190304\_00043.jpg

LM Start	49.42	Rating **	A/W	Issue No.	113
LM End	49.42	Issue Type +	Ma	Location *	WS
Category	Earthen Levee			GPS Latitude/Longitude	
				Start	End
Item	Erosion / Bank Caving			39.213303 °	39.213303 °
				-121.996915 °	-121.996915 °
DWR ID	DWR_NA0016_01_f_2018_113				
Comment Code					
E1 : Note and monitor erosion site.					
Inspector Comment					
Runoff erosion is located on the waterside berm. Recommend monitoring.

View of erosion on the waterside berm. Fall 2018.

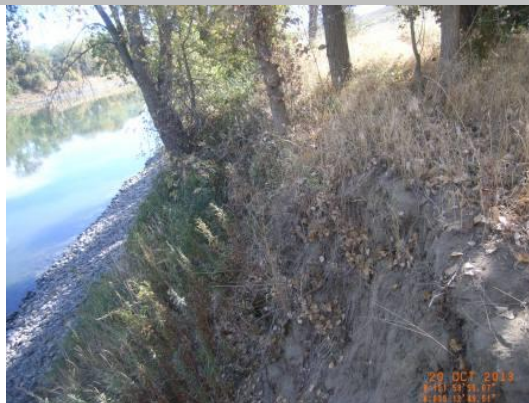
Photo 1 of 1 : SP\_2019\_NA0016\_435\_105\_20190304\_00036.jpg

LM Start	49.46	Rating **	A/W	Issue No.	105
LM End	49.57	Issue Type +	Ma	Location *	WS
Category	Supplemental			GPS Latitude/Longitude	
				Start	End
Item	2017 USACE Erosion Survey, DRAFT			39.213608 °	39.213869 °
				-121.997543 °	-121.999641 °
DWR ID	DWR_NA0016_01_f_2018_105				
Comment Code					
Inspector Comment					
2017 Site ID: SAC 143.5 R Status: Eroding 2017 Field Notes: New erosion along lower slope. Site History: 2011 - Multiple scallops, one tree pop out. Old cobble site starting to unravel at midbank. 2012 - Mid bank slumping continues to worsen but cobble at the toe appears stable.					
DWR Inspector Comment: Erosion on the waterside berm. Recommend monitoring.
